## **“Original State” of Concrete / Clay Roof Tile Being Shipped from a Manufacturing Facility**

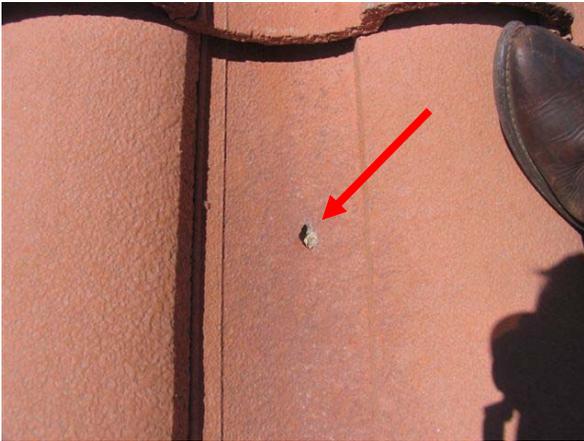
*Picture of Hail Damage creating "blow out"*

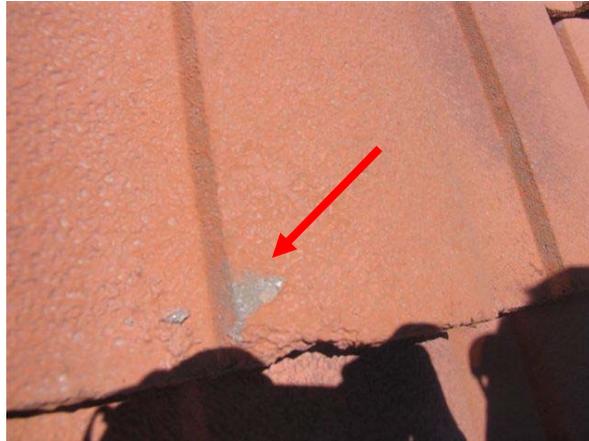
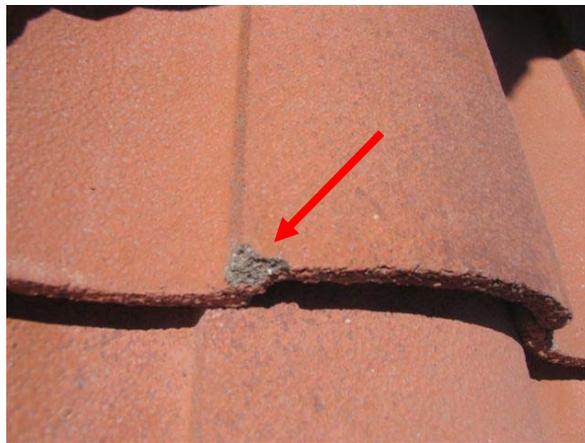
*Pictures of chipping to edge of slurry coated tile*
